MARYLAND GEOLOGICAL SURVEY
Merryman Hall
The Johns Hopkins University
Baltimore, Maryland 21218
(301) 338-7156

COUNTIES (MD/PA) GARRETT/SOMERSET
M&D milestone no. --- (205)
MHT-HSI no. G-IIB-250

FIELD SHEET: MASON & DIXON LINE, MARYLAND-PENNSYLVANIA BOUNDARY MARKER SURVEY

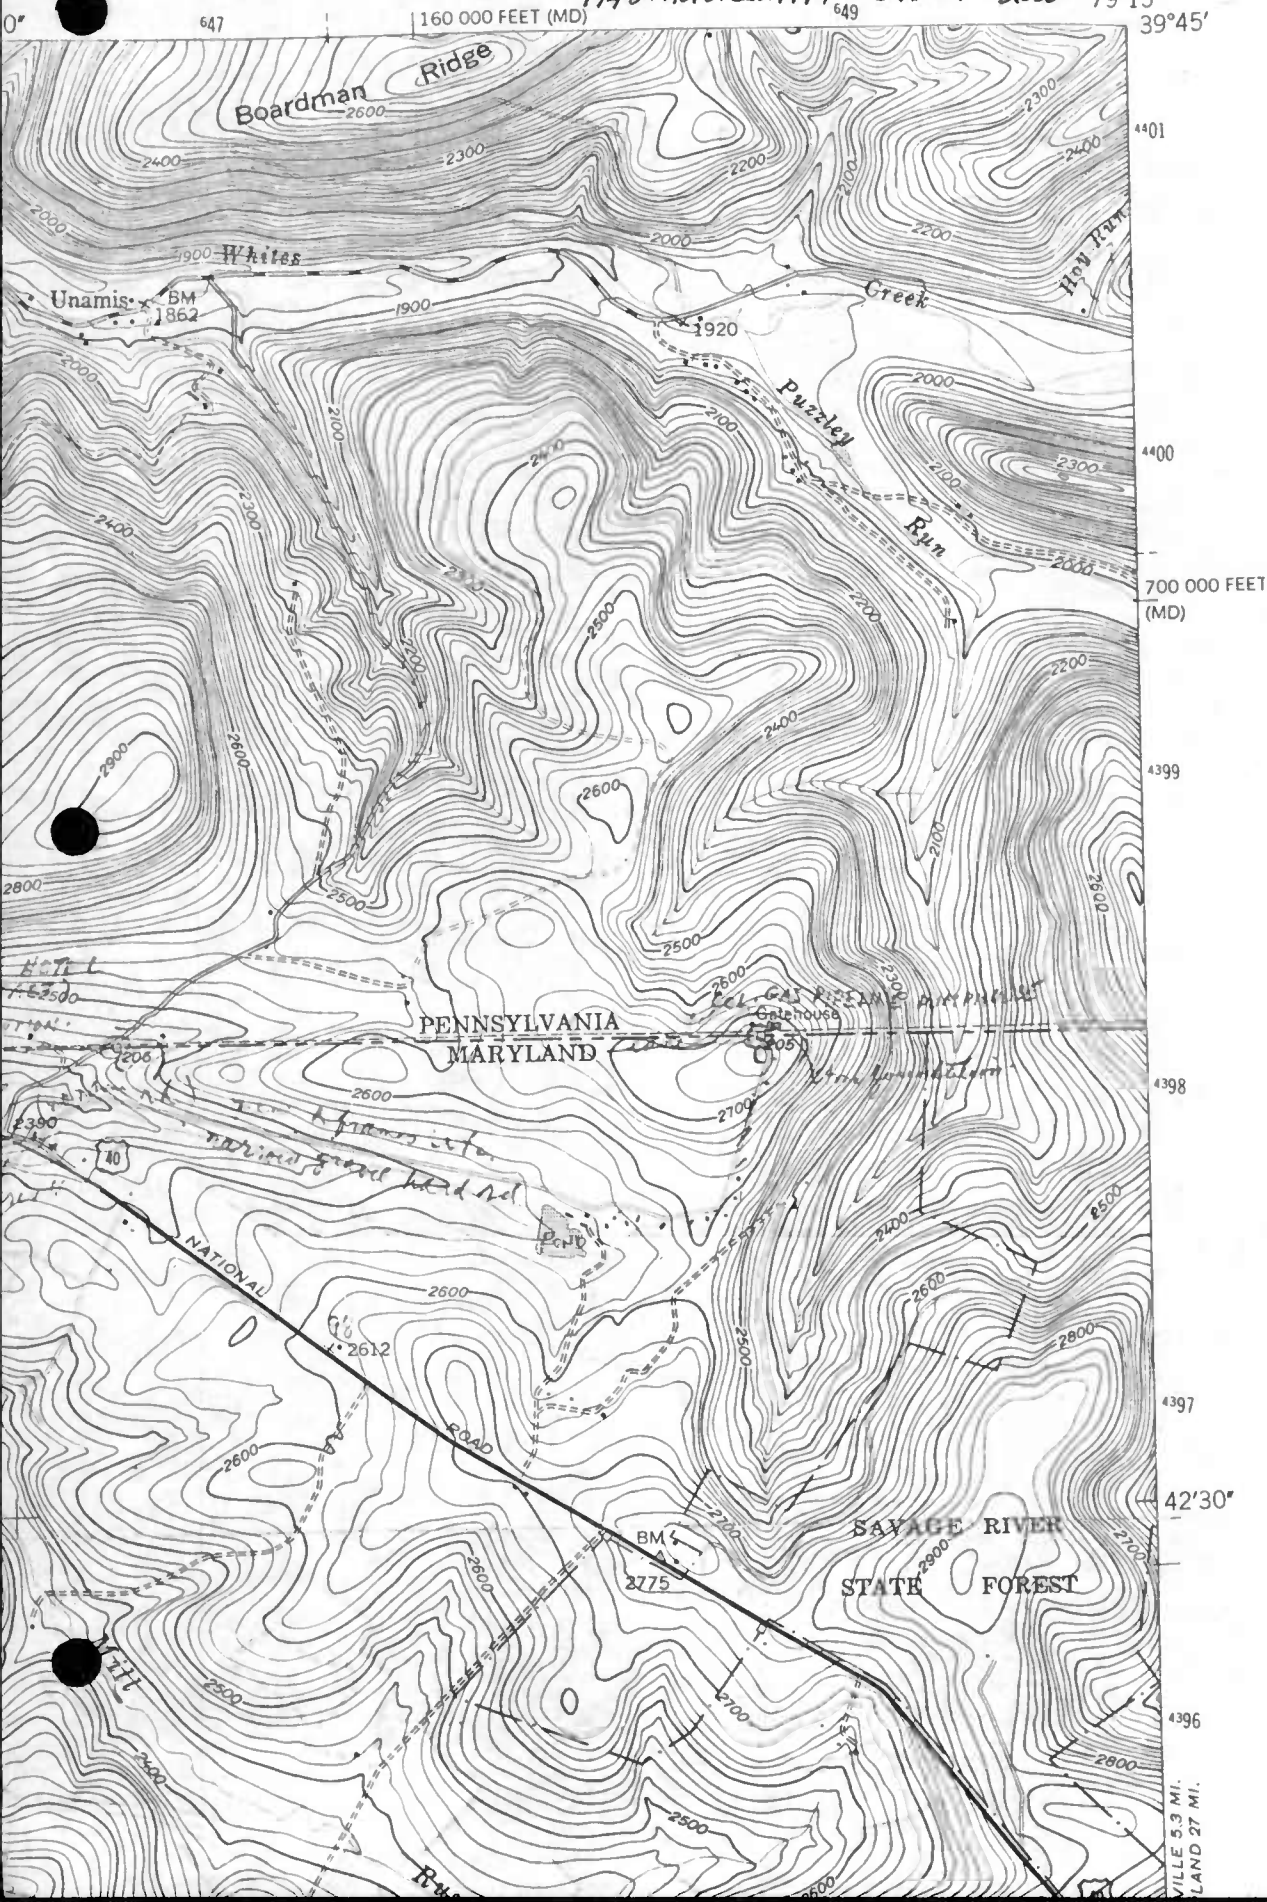
addition (1902) to site of former large earth mound, believed original M&D of 1767,
N face (PA): 10 1/4" wide x 17" high; P clear & intact; small nicks NE & NW edges

E face: 10" wide x 20" high; 1767 clear & intact; small nicks NE & SE edges

205. Monument in good condition; firmly set but leaning to north. Lettering good.

1979-81 Inspection notes: order no. --- (205); photos/negatives/slides no. --- (205)
--- (205). New stone monument addition (1902) to site of former large mound of earth
believed original M&D of 1767, no longer noticeable. Monument in place, though
leaning slightly to NE, in excellent condition, firmly set. Letters and dates
clear and intact. Protected (until development) by inconspicuousness of site.

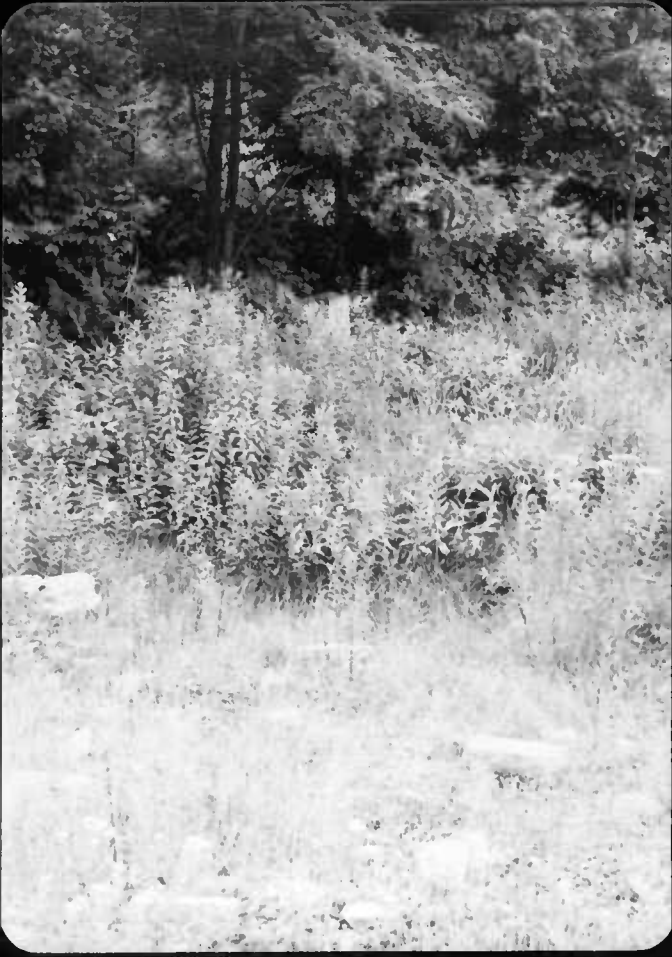
PHOTO: ALICE MARTIN 7/25/81 (1981.2310)

MED WEST LINE: MILESTONE — (205)
VIEW SW, SHOWING SCATTERED
STONES OF KEYSER RIDGE GATEHOUSE
REMAINS & MILESTONE — (205)
IN BACKGROUND
AN E-W DEVELOPMENT LANE
RUNS ALONG PARALLEL IN BACK
OF FENCE ROW & IS ACCESS TO
SITE

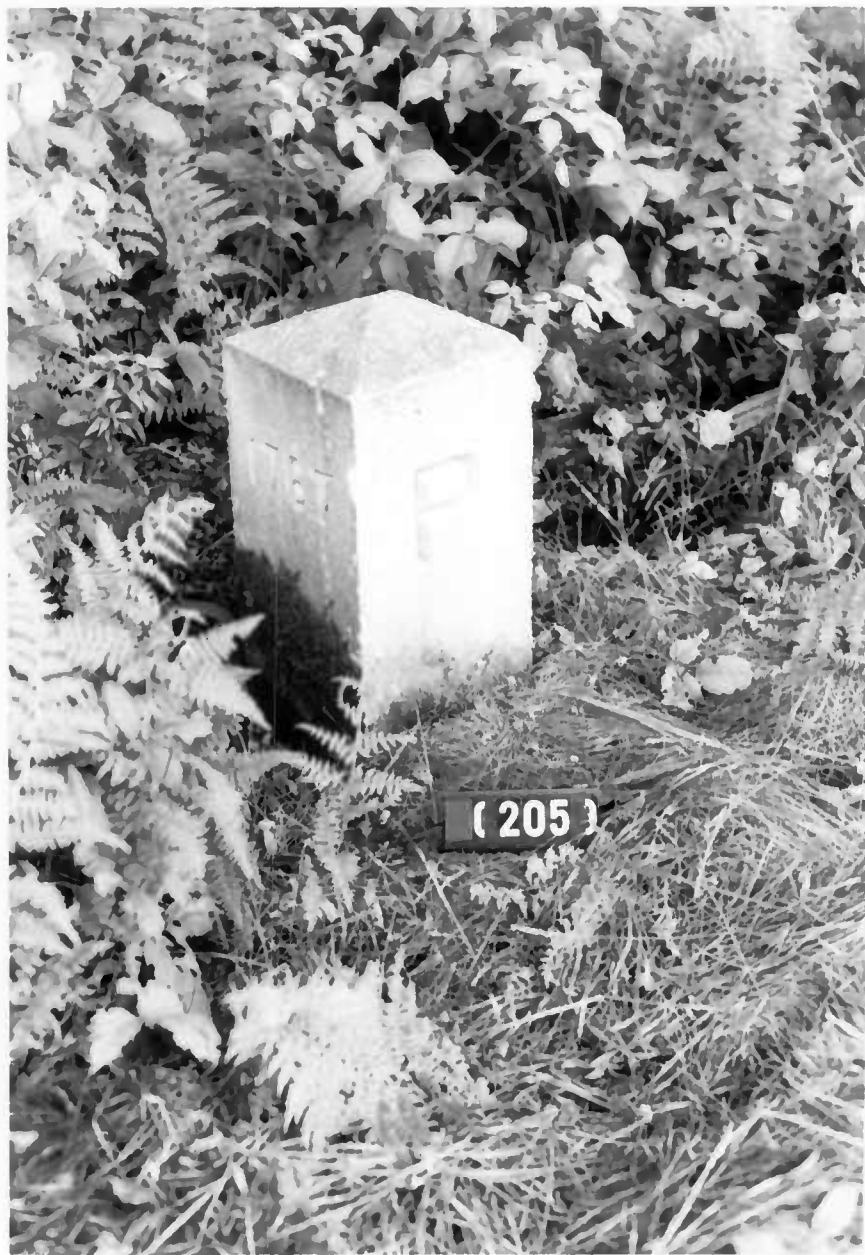
NE CORNER (205)

MASONRY WORK ON THE SIDE - (205)

PHOTO: SIDE VIEW OF THE SIDE (17.5)
